***Data Analysis of the Marengo River Watershed. AW Research Lab, Inc.
February 2004.***

***(aerial photo analysis for nonpoint pollution sources on and off Bad River
Reservation)***

Marengo River
Watershed
Influence Maps

Subject: Statistical Review and Recommendations for the Marengo River Watershed
Aerial Survey and Analysis

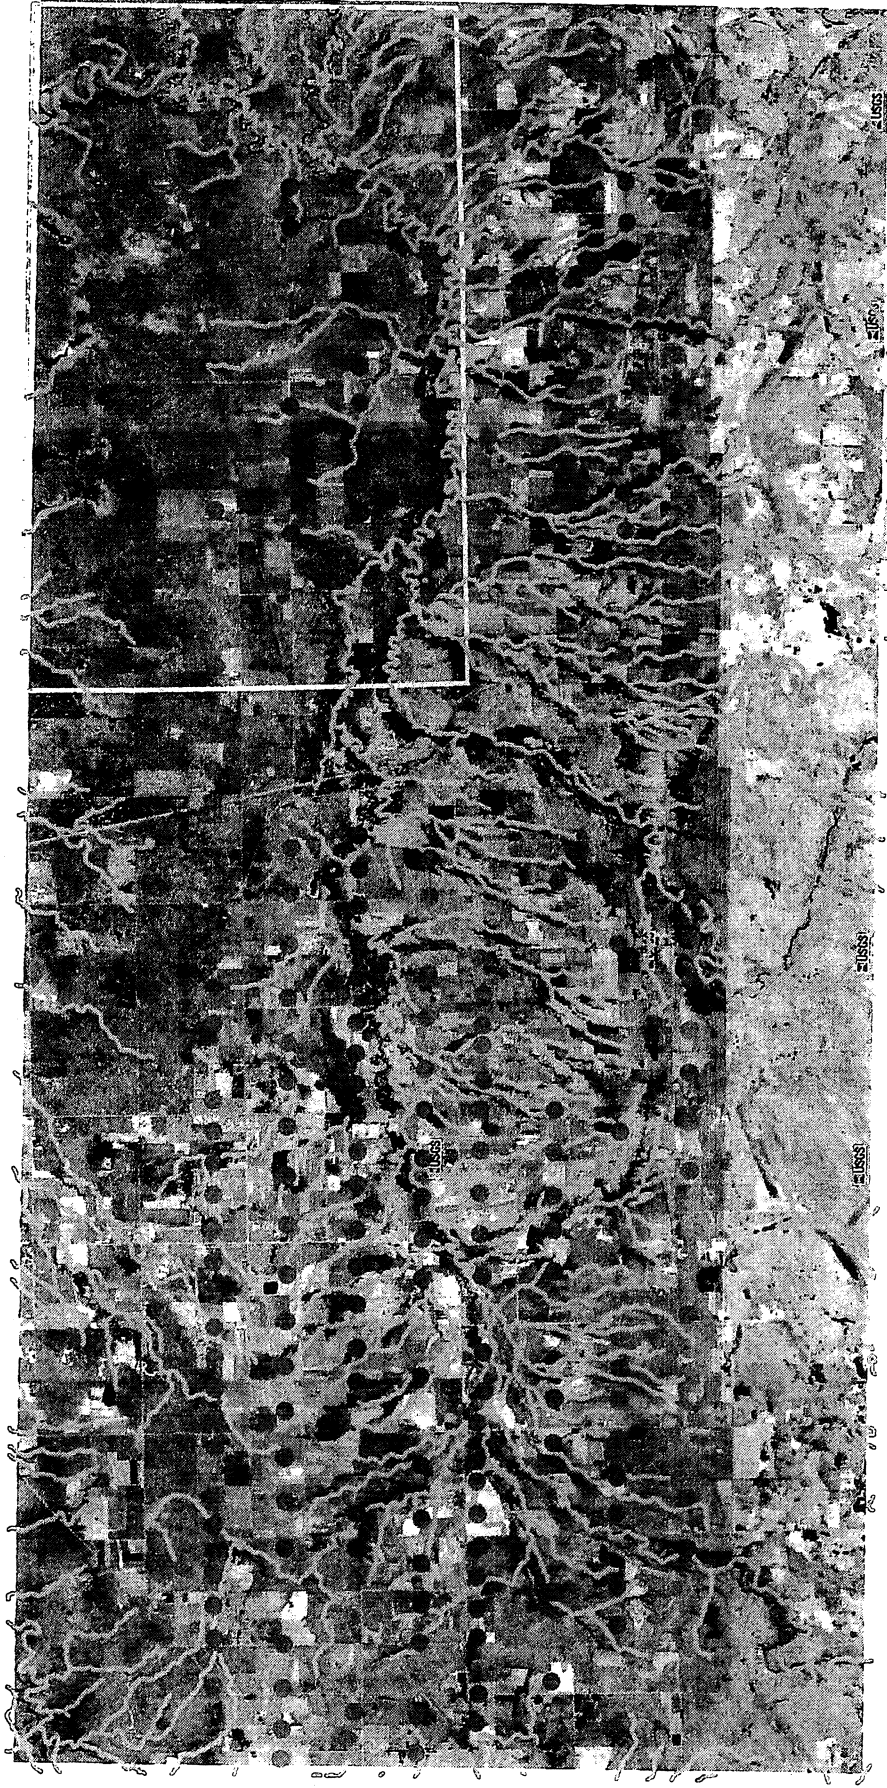
Non-point Runoff Barren Fields

***The portion reproduced here includes only the summary report and
example summary overlays for the study area. Note that the squared line
in the included summary aerial photos delineates the southwestern
boundary of the Reservation. Influences counted occur both on and off
the Reservation. The main body of this report consists of the actual 353
aerial photos that were analyzed to create this report.***

Non-point runoff barren field

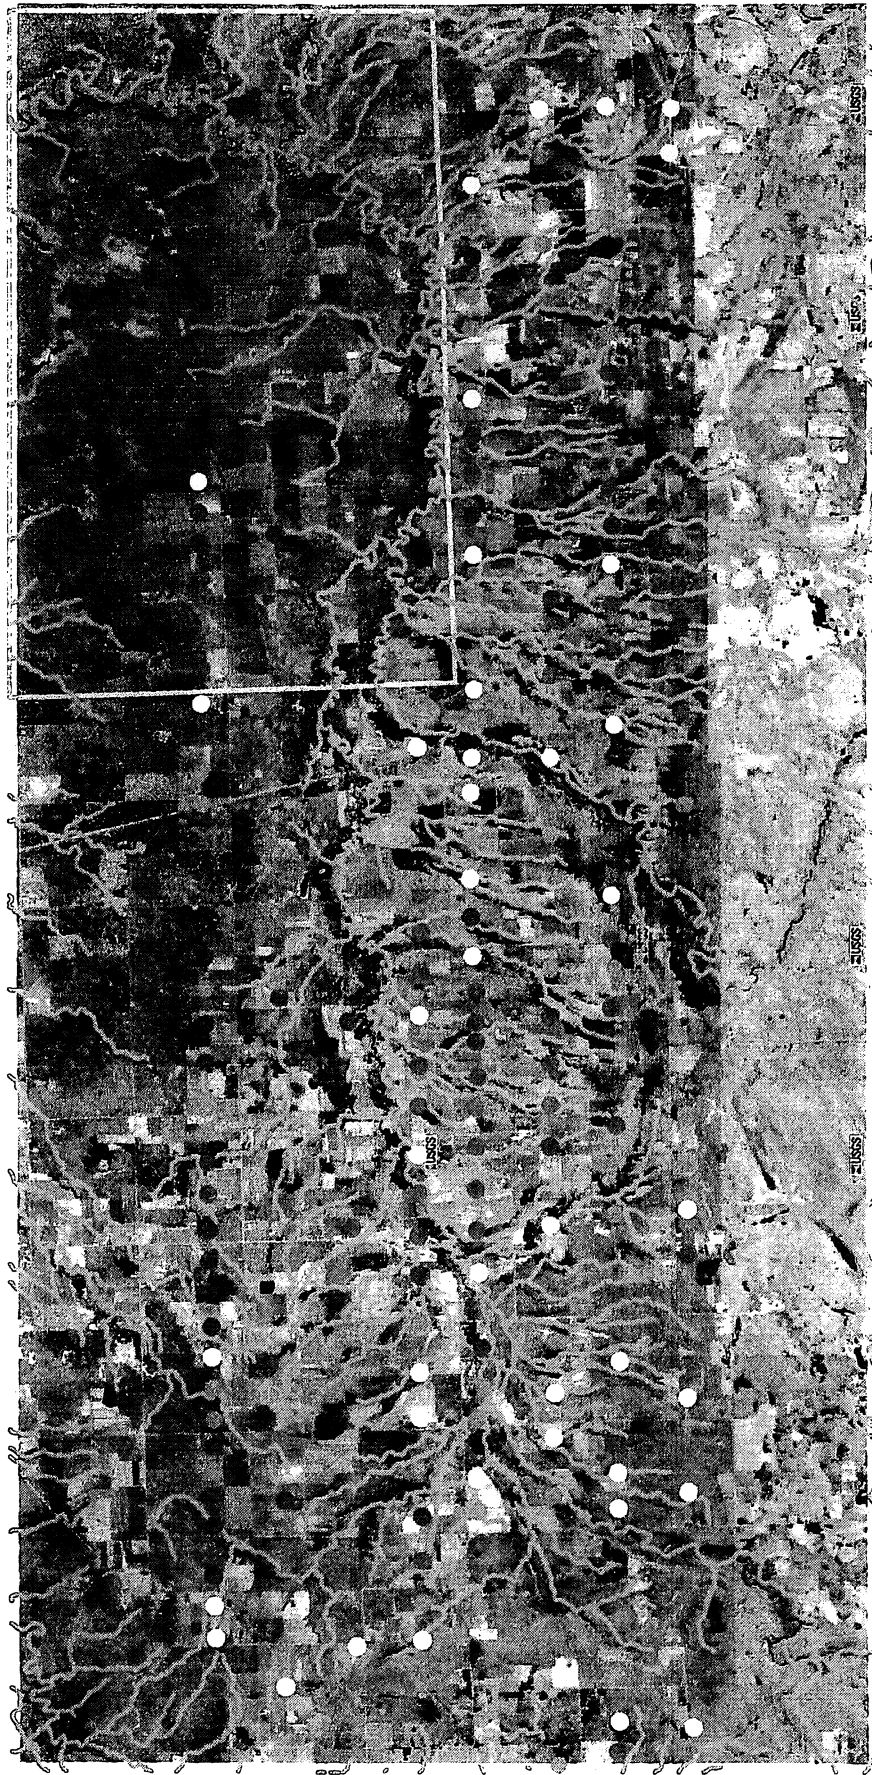
Runoff Point Sources

Runoff point source
